DRAFT MEMORANDUM

Re: Avery Landing Site
Draft Evaluation of Free Product Recovery System

Attachment 1
FPRS Record Drawings

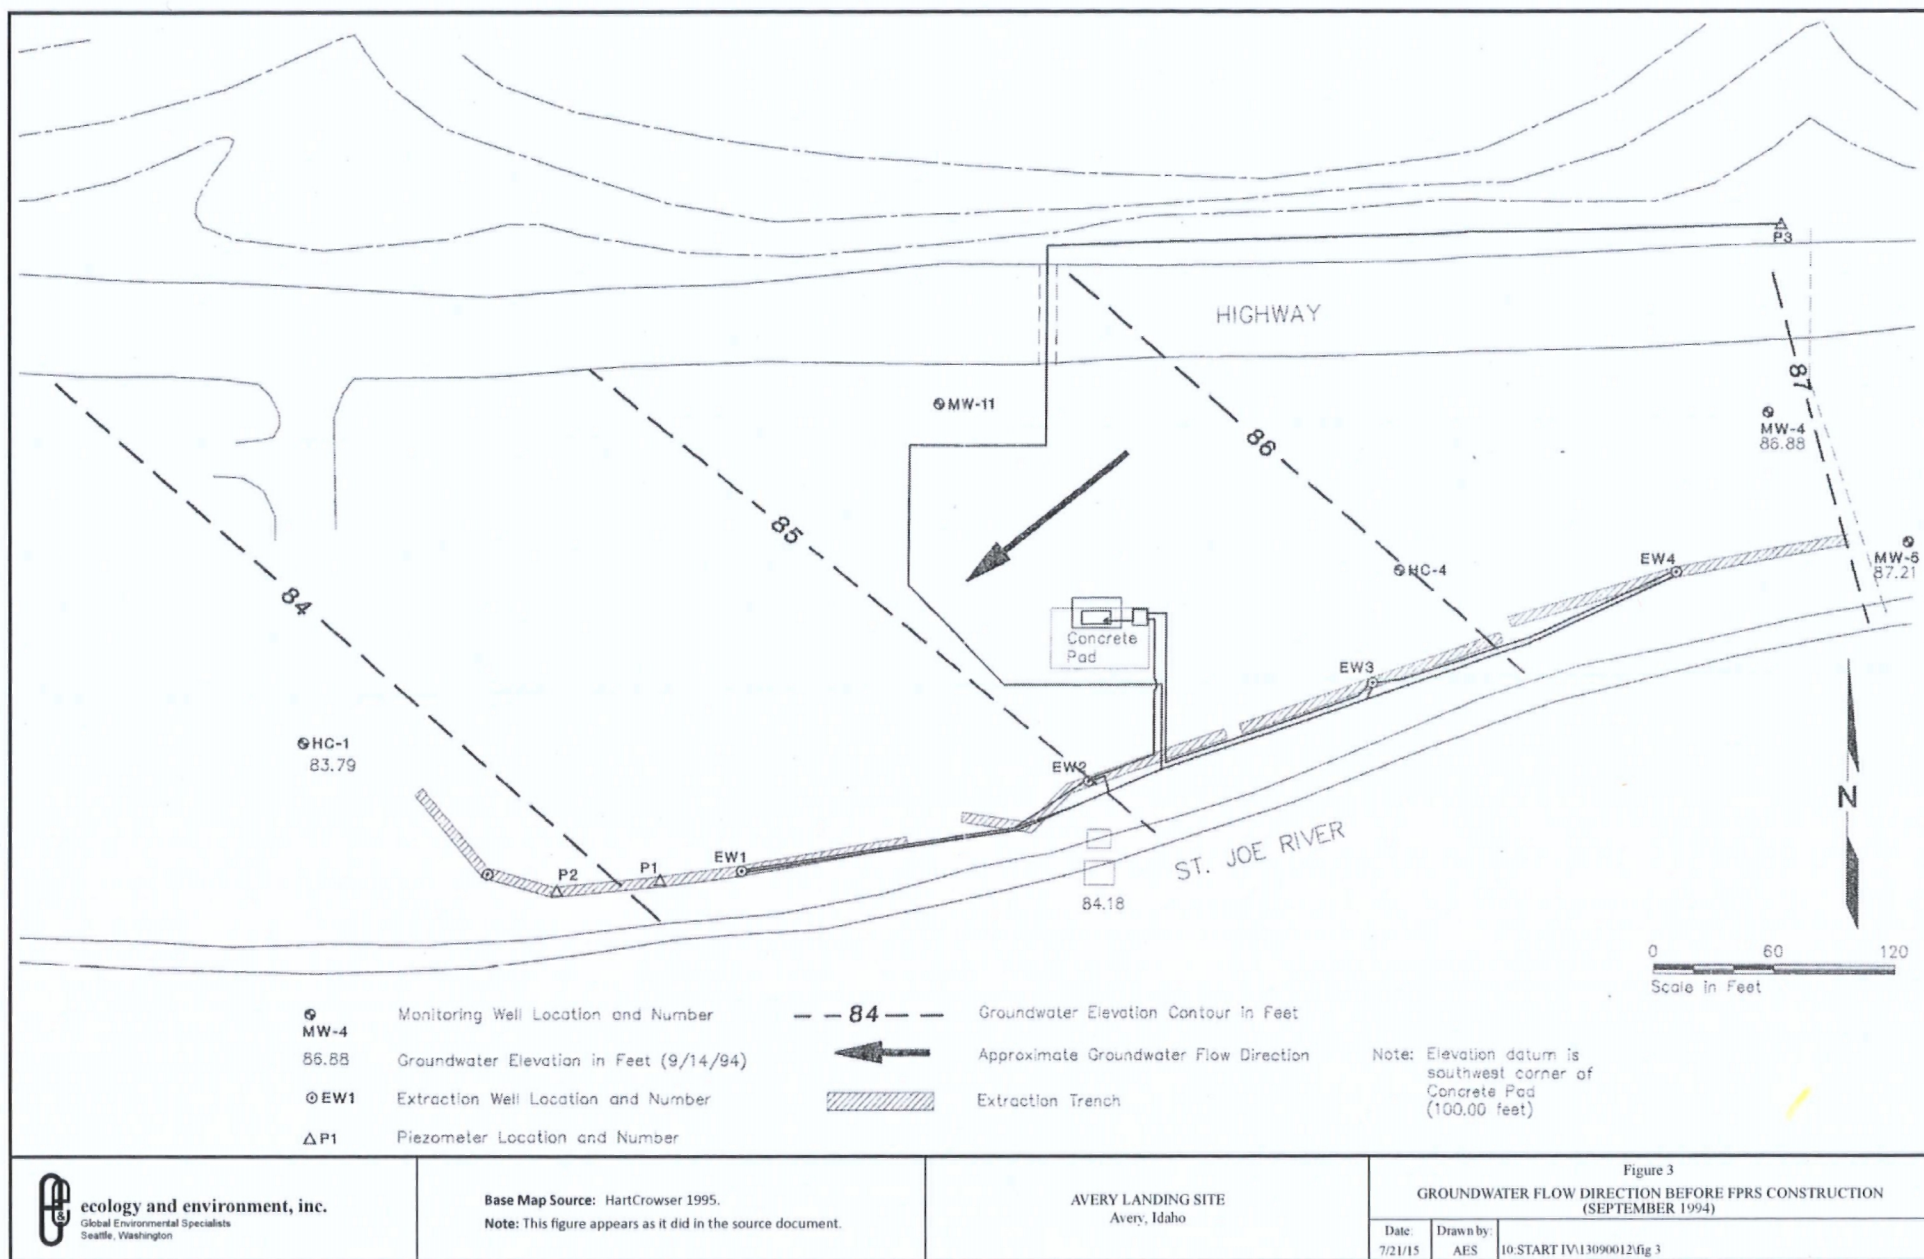
In general, groundwater flow at the Site has been estimated to be toward the southwest. Figure 3 shows groundwater elevations and a southwestern groundwater flow from September 1994. While the FPRS was operating, Hart Crowser measured and estimated changes in hydraulic gradients and contours caused by the operation of FPRS extraction well pumps. See Figure 4 from June 1995, which indicates a more southerly groundwater flow direction from the infiltration trench while the FPRS was operating. (Hart Crowser 1995)

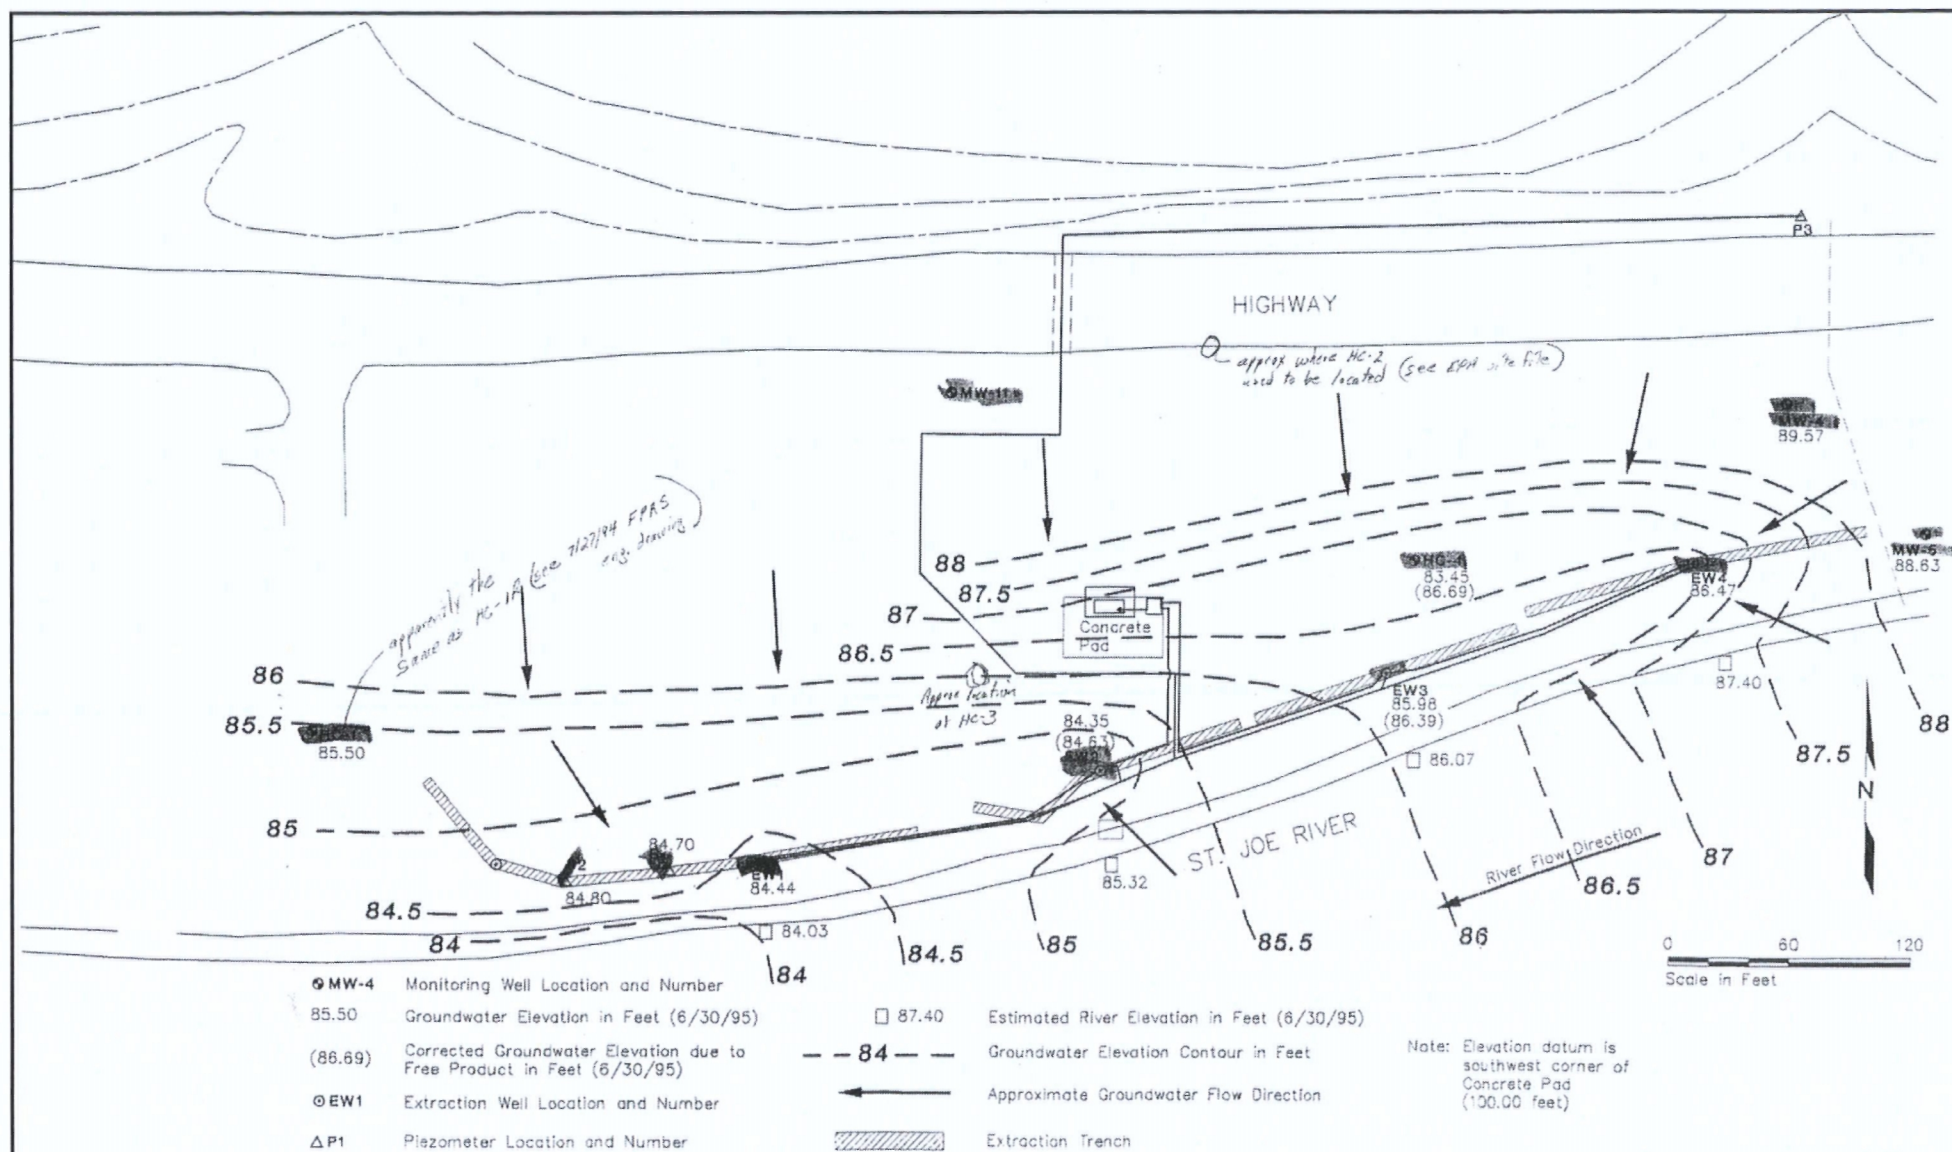
Based on the location of the infiltration trench and the groundwater flow direction during the operation of the FPRS (Figure 4), it is likely that oil discharged from the infiltration trench north of the highway would have migrated to the south.

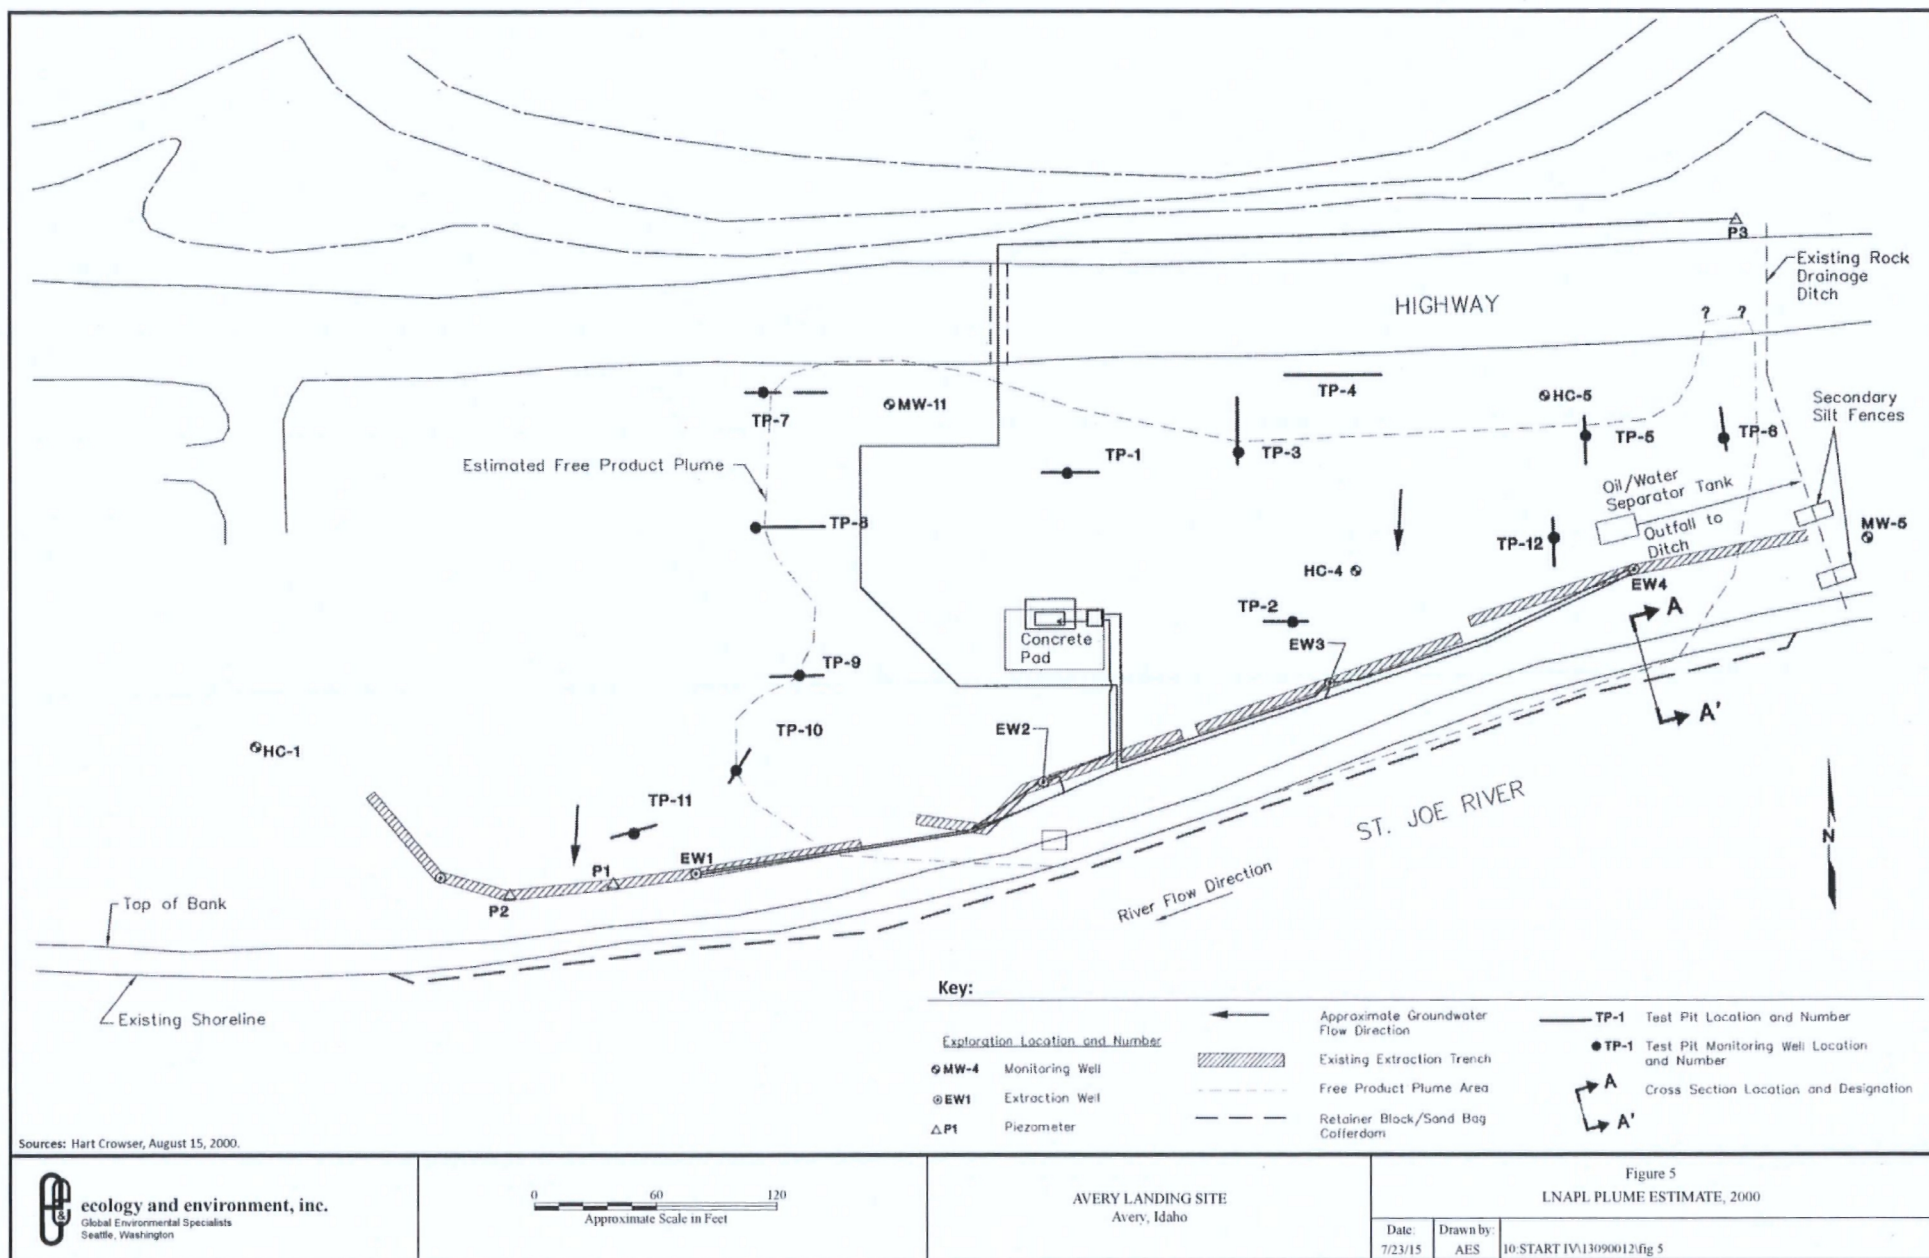
The first known estimate of the extent of the LNAPL plume at the Site was prepared by Hart Crowser for Potlatch based on test pits excavated in June 2000 (Figure 5). This 2000 plume estimate indicates that the northern boundary of the LNAPL plume is south of the highway, based on the observations of no visible free product in Test Pit (TP)-4. However, note that no test pits were excavated north of the highway in the area of the infiltration trench (Hart Crowser 2000).

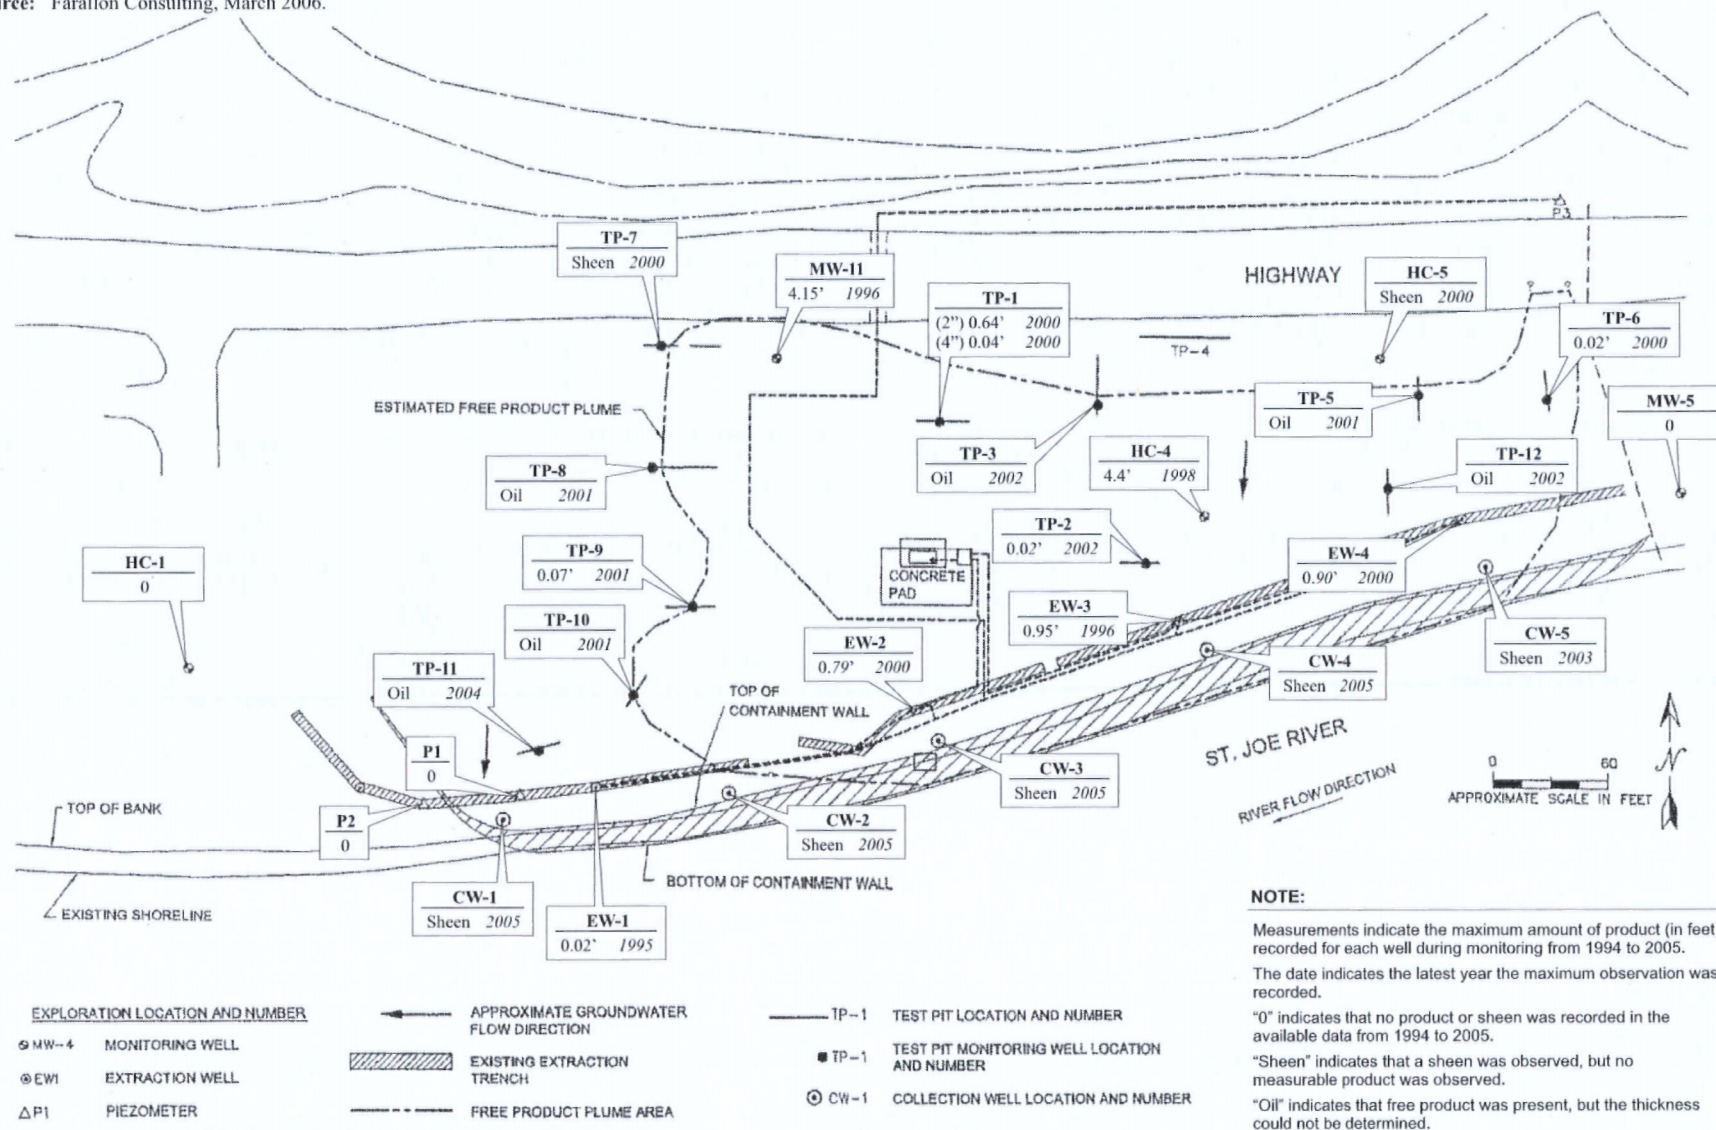
<p>ecology and environment, inc. Global Environmental Specialists Seattle, Washington</p>	<p>AVERY LANDING SITE Avery, Idaho</p>	<p>Figure 6 ESTIMATED FREE PRODUCT PLUME IN 2000 AND HISTORIC MAXIMUM PRODUCT THICKNESSES</p>		
		<p>Date: 7/23/15</p>	<p>Drawn by: AES</p>	<p>10:START-IV\13090012\fig 6</p>

Hart Crowser and Potlatch monitored the various Site monitoring and extraction wells over time from 1994 through 2005. Figure 6 includes a map of the various monitoring wells, extraction wells, and slotted PVC pipes (i.e., test pit monitoring wells) located at the Site, and it includes the maximum amount of product recorded and the year for each of these wells. The test pit monitoring wells at test pit locations TP-3 and TP-5 are most directly south of the infiltration trench area, on the south side of the highway. In both of these wells, sheen was observed on the initial monitoring period in June 2000, while later, in 2001, monitoring indicated traces of oil in both.

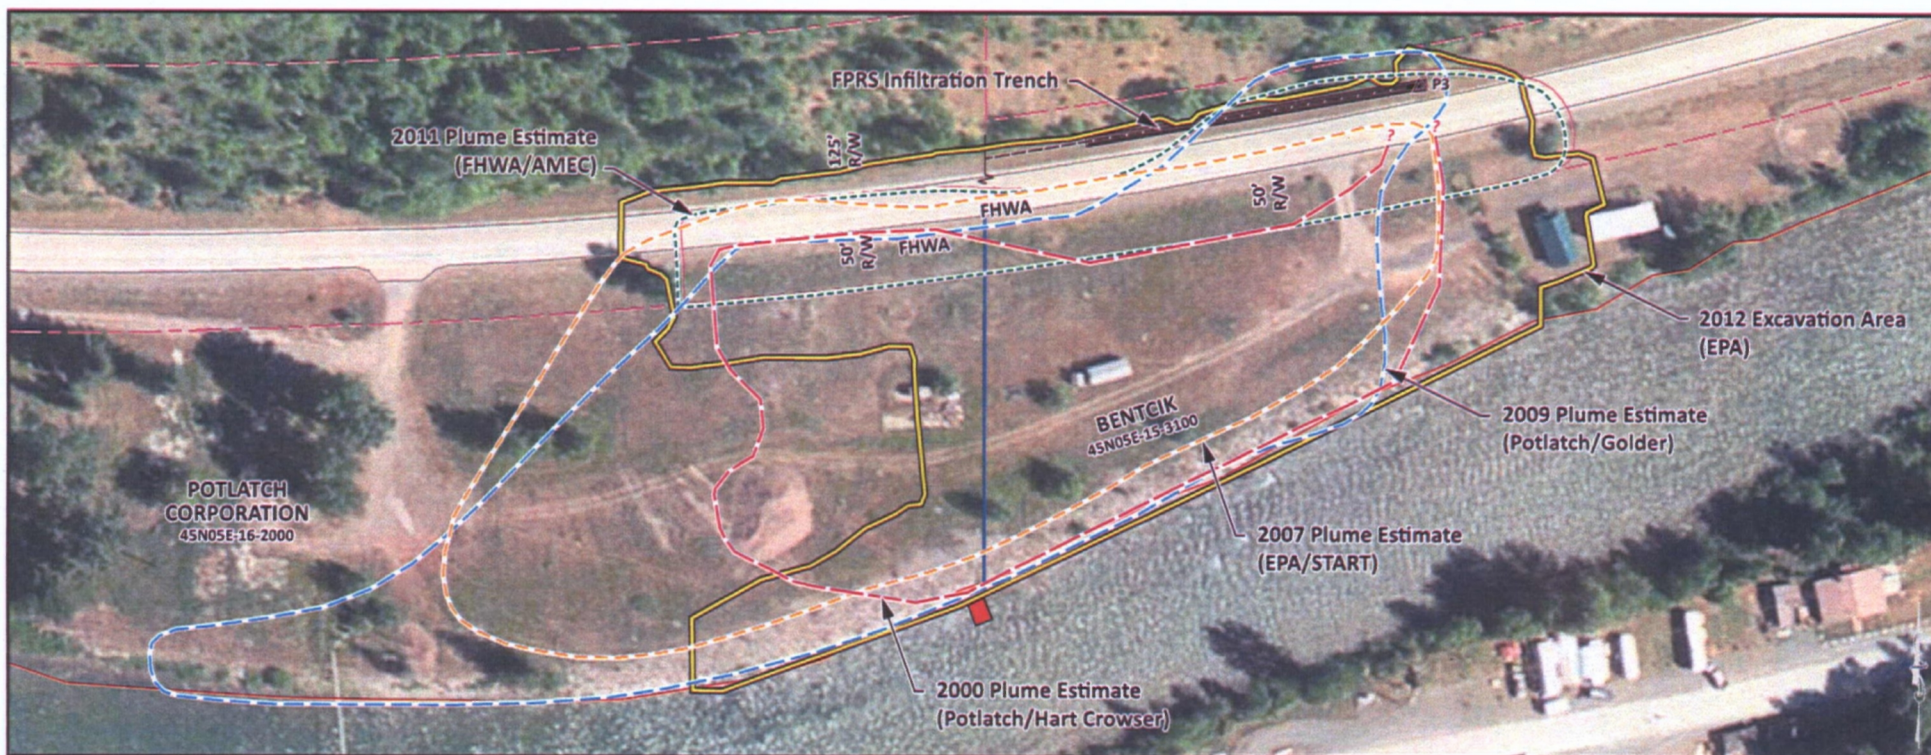
Figure 7
LNAPL PLUME ESTIMATES AND EPA EXCAVATION AREA

- Potlatch/Bentcik Property Line
- Property Line Idaho Department of Lands
- - - Right of Way Property Line Federal Highway Administration
- - - 2000 Plume Estimate (Potlatch/Hart Crowser)
- - - 2007 Plume Estimate (EPA/START)
- - - 2009 Plume Estimate (Potlatch/Golder)
- - - 2011 Plume Estimate (FHWA/AMEC)
- 2012 Excavation Area (EPA)
- ▨ FPRS Infiltration Trench

Note: The plume estimates were located as accurately as possible based on the indicated source materials.

As indicated above, the first known LNAPL plume area estimate was prepared in 2000 by Hart Crowser on behalf of Potlatch. Since then, additional LNAPL plume area estimates have been prepared as a result of subsequent investigations, including EPA in 2007, Golder Associates (on behalf of Potlatch) in 2009, and the FHWA in 2011. These estimated LNAPL plume areas are indicated on Figure 7, as well as the excavation area from EPA's 2012 removal action (which only included the eastern half of the Site; Potlatch completed the removal action on their western half of the Site in 2013).

The various LNAPL plume area estimates and the 2012 EPA excavation were digitized in GIS. The areas of each, including the area located within the highway right-of-way, are presented in Table 1. In general, each subsequent investigation resulted in an expanded estimated LNAPL plume area, although it is not clear whether this is because the LNAPL plume continued to expand during this time or because the investigations became more accurate as they built on previous investigations and focused on areas that required additional delineation. Also, note that these LNAPL plume estimates are of the horizontal area, only, and do not include depths or volume estimates.
